Blue Water Bridge Plaza Study

MDOT J.N. 57779

Technical Memorandum Project Area Contamination Survey Report

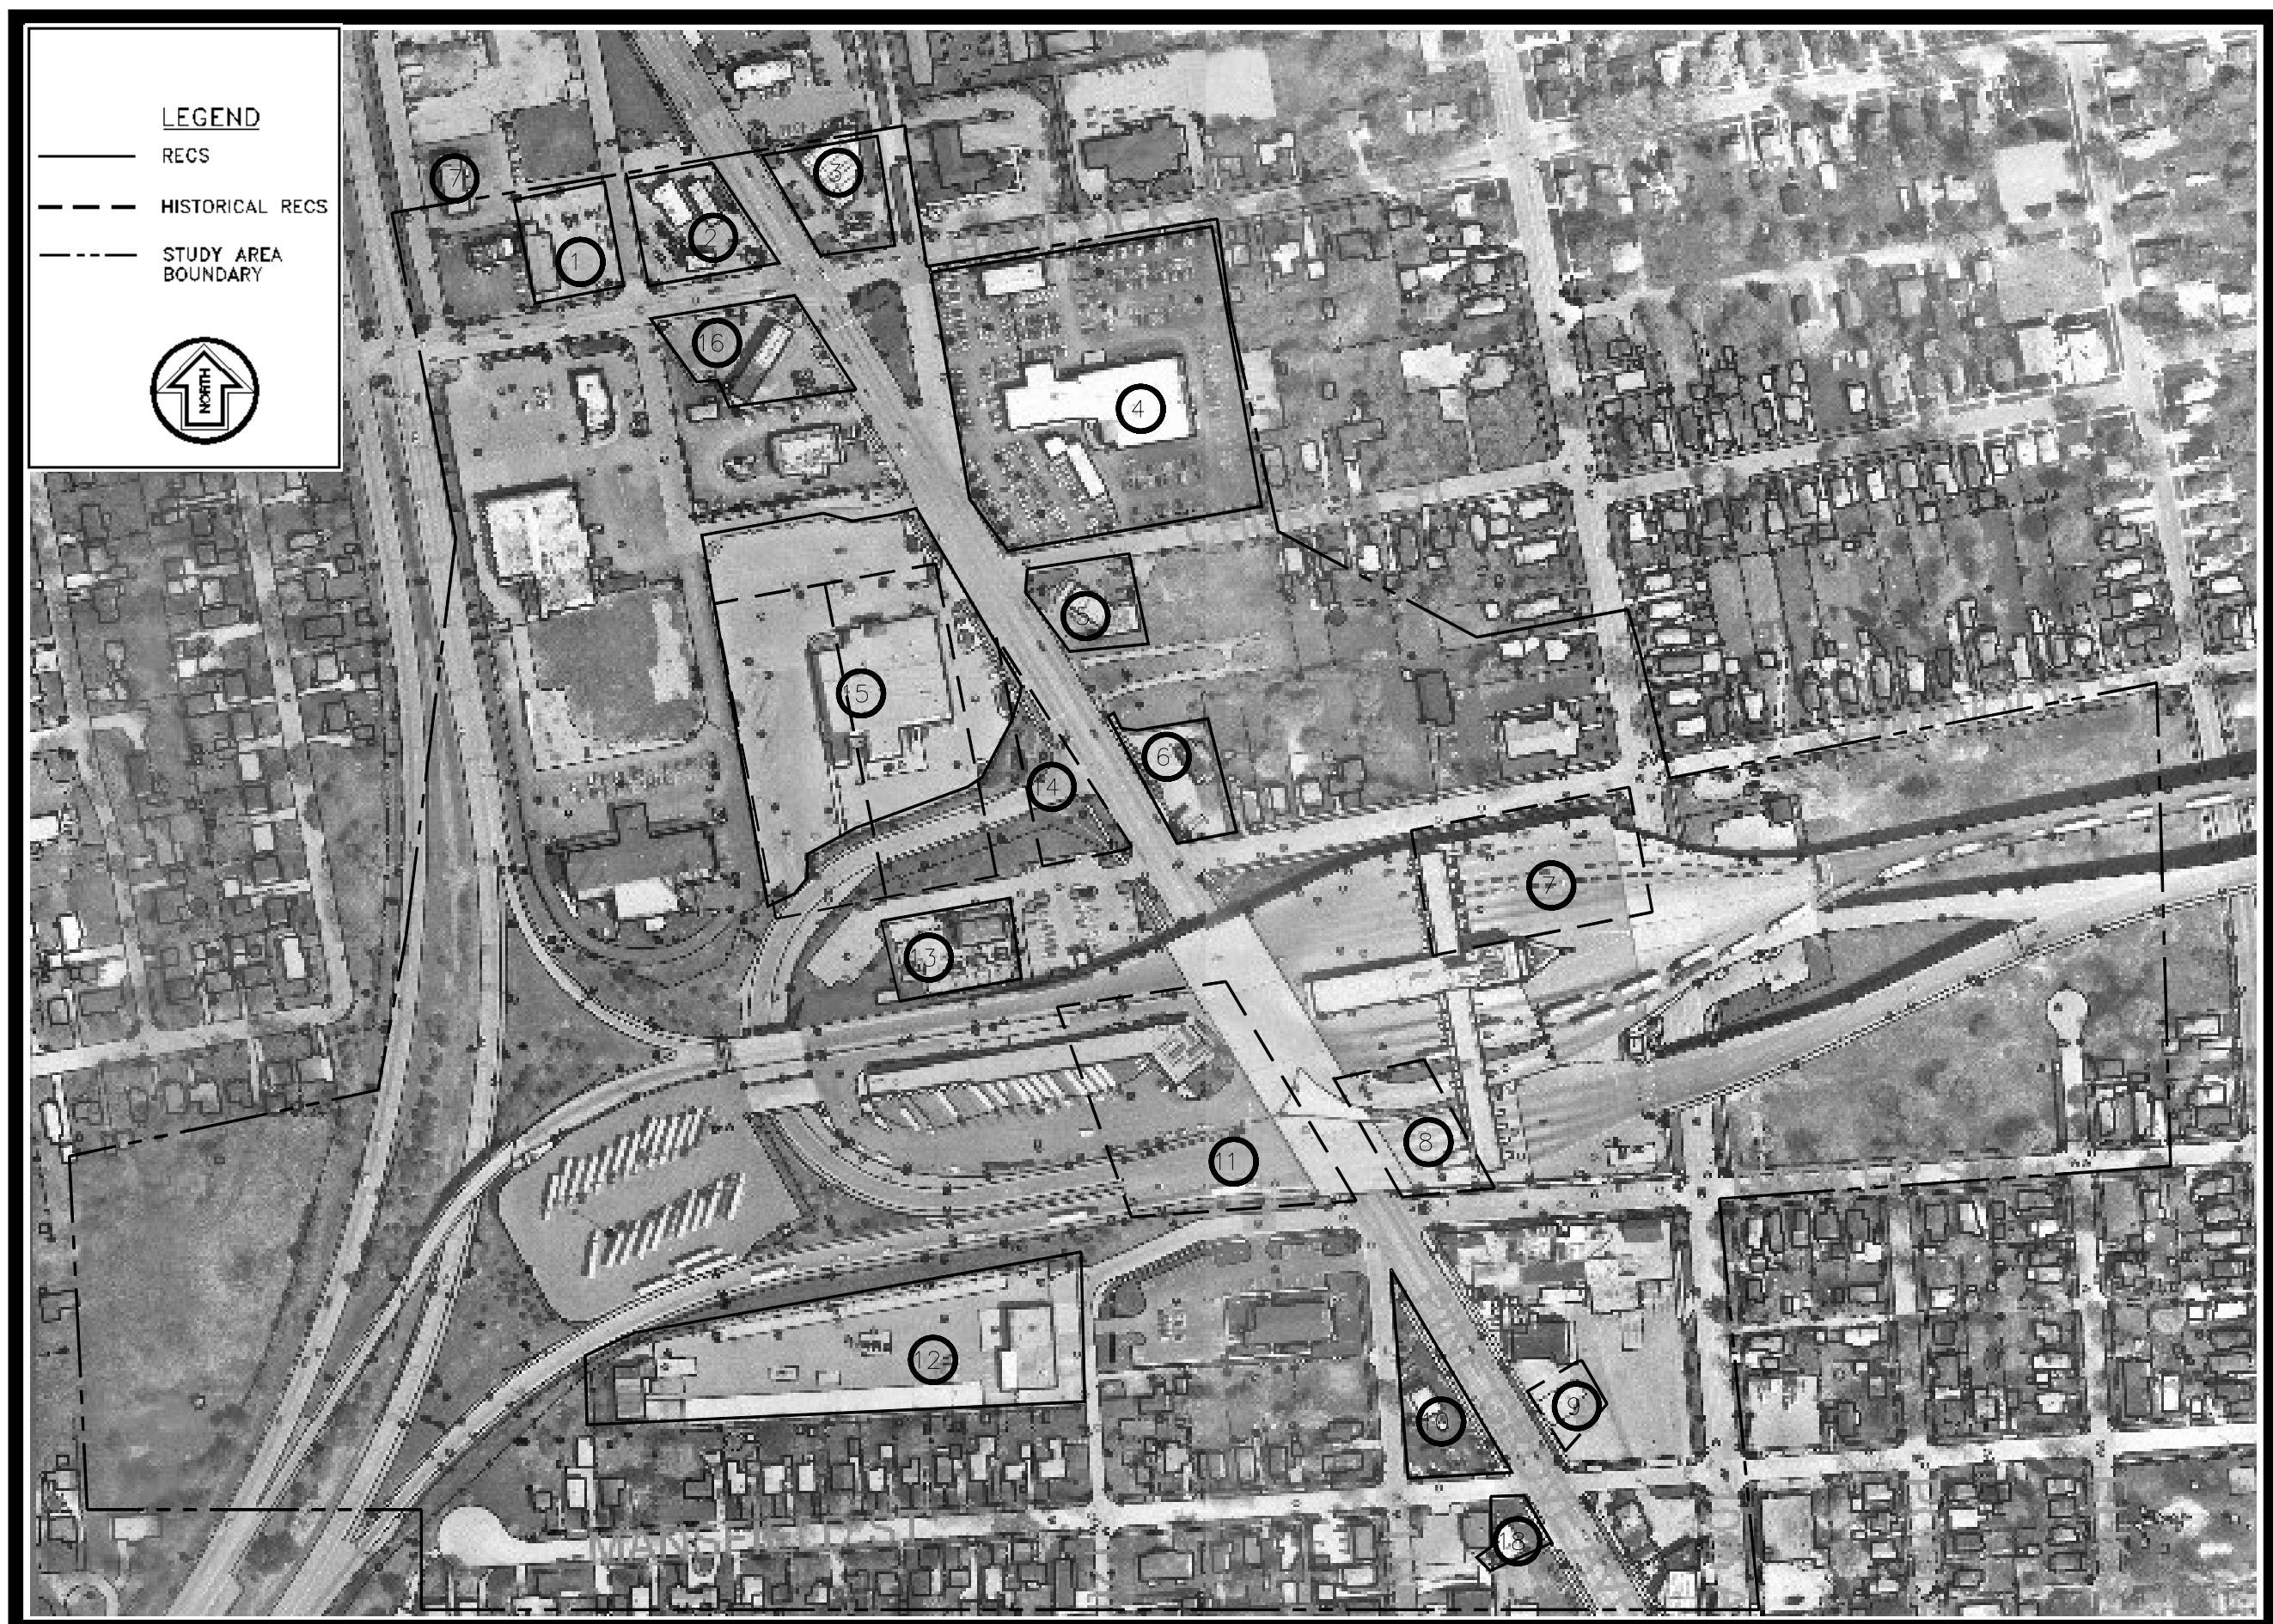
Appendix A: Figure 1

SME's Study Area included assessing land east of I-94 and a vacant parcel west of I-94; land south of Hancock Street and west of 10th Avenue; and north of Mansfield Street. The preliminary expansion alternatives covered approximately 100-acres of land. With the exception of a vacant parcel just west of I-94, which was approximately 4-acres of wooded land. The Study Area is attached and labeled as **Figure 1**.

Site 1: The site located at 2601 13th Avenue on the northern portion of the Study Area, appeared to be residential from at least 1948 until the early 1970s. From the early 1970s until the present, it appeared to be a car wash. This site is currently Buffs Auto Wash. This site is further discussed in Section 3.6.1, and is identified as #1 on the attached **Figure 1**.

Site 2: The site located at 2621 Pine Grove Avenue located on the northern portion of the Study Area, appeared to be residential from at least 1948 until the late 1950s. The site was a parking lot for its north adjoining site from the late 1950s until the late 1960s. The site appeared to be a gas station from the mid to late 1960s to the present. The site is currently Speedway Gas Station. The presence of a gas station located on this site represents a REC in connection with the Study Area. This site is identified as #2 on the attached **Figure 1**.

Site 3: The site located at 2610 Pine Grove Avenue on the northeastern portion of the Study Area, appeared to be a gas station since at least 1926 until the present. An addition was made to the building on this site apparently in the mid 1980s. This site is currently a Marathon Gas Station. The presence of a gas station located on this site represents a REC in connection with the Study Area. This site is identified as #3 on the attached Figure 1.

Site 4: The site located at 2516 Pine Grove Avenue, on the northeastern portion of the Study Area, appeared to be residential from at least 1948 until the late 1950s. From the late 1950s until the present the site was an automobile dealership and garage. The site and the buildings expanded in the late 1970s. The site is currently CaWood Auto Sales. The presence of an auto service garage represents a REC in connection with the Study Area. This site is identified as #4 on the attached **Figure 1**.

Site 5: The site located at 2432 Pine Grove Avenue, on the eastern portion of the Study Area appeared to be residential from at least 1948 until the late 1950s. From the late 1950s until the late 1980s the site appeared to be an auto dealership. From the late 1980s until the present the site appeared to be a gasoline station. The site is currently USA Petroleum Gas Station. The presence of a gas station located on this site represents a REC in connection with the Study Area. This site is identified as #5 on the attached **Figure 1**.

Site 6: The site located at 2402 Pine Grove Avenue, on the eastern portion of the Study Area appeared to be vacant prior to the early 1940s. From the early 1940s to the early 1980s the site appeared to be a gas station under various names. From the early 1980s until the early 1990s the site appeared to be a market place, food store. From the early 1990s until the present, the site appeared to be a vacant building. The historical presence of a gas station located on this site represents a REC in connection with the Study Area. This site is identified as #6 on the attached **Figure 1**.

Site 7: The site located at 1410 Elmwood Street did not appear in aerial photographs or Sanborn Maps. This site was reportedly underneath the former Blue Water Bridge prior to construction of the existing plaza in the mid 1990s. This site is further discussed in Section 3.6. This site is a REC in connection with the Study Area and is identified as #7 on the attached **Figure 1**.

Site 8: The site located at 2308 Pine Grove Avenue appeared to be a gas station from at least 1948 until the mid 1990s when the Blue Water Bridge Plaza was extended. It appears the building on this site was demolished, and the Blue Water Bridge Plaza addition was built on top of the site. This site is further discussed in Section 3.6.1. This site is a REC in connection with the Study Area and is identified as #8 on the attached **Figure 1**.

Site 9: The site located at 2108 Pine Grove Avenue on the southeastern portion of the Study Area appeared to be residential until the early 1960s. From the early 1960s until the late 1970s the site was a gas station. From the late 1970s until the mid 1980s the site appeared to be an addition to London's Dairy, which is it's north adjoining site. The historical presence of a gas station located on this site represents a REC in connection with the Study Area. This site is identified as #9 on the attached **Figure 1**.

Site 10: The site located at 2111 Pine Grove Avenue located on the southern portion of the Study Area appeared to be vacant prior to the mid 1930s. From the mid-1930s until the early 1960s the site appeared to be an auto dealership and service garage from the early 1960s until the present. The site also had an address under 2107 Pine Grove Avenue. This site is currently Guizar's Auto Company. The presence of an auto service garage represents a REC in connection with the Study Area. This site is identified as #10 on the attached **Figure 1**.

Site 11: The site formerly located at 2201 Pine Grove Avenue on the southwestern portion of the Study Area appeared to be vacant prior to 1918. From 1918 until the late 1960s the site appeared to be used as a coal storage and distributing facility. A railroad spur appeared on the site in the 1948, 1958, and 1961 aerial photographs, and is also observed in the Sanborn Fire Insurance Maps. From the late 1960s until the mid 1990s the site had one rectangular building

with an associated parking lot. The aerial photographs for the years 1978 and 1986 appeared to have dark colored soil on the northwestern portion of the site with vehicle tracks leading to the colored soil. It appears the building on this site was demolished, and the Blue Water Bridge Plaza addition was built on top of the site. The presence of a railroad spur and a coal yard represent a REC in connection with the Study Area. This site is identified as #11 on the attached **Figure 1**.

Site 12: The site located at 2119 12th Avenue located on the southwestern portion of the Study Area appeared to be vacant agricultural land prior to the early 1950s. From the early 1950s until the 2001, the Site was used as the London's Dairy Truck Stop. A pump island appeared in the 1998 aerial photograph located in the central portion of the site. The building on this site is reportedly vacant. This site is further discussed in Sections 3.2.2 and 3.6.1. This site is considered a REC based on the existing UST in the central portion of the site. This site is identified as #12 on the attached **Figure 1**.

Site 13: The site located at 1508 Elmwood Street located on the western portion of the Study Area, appeared to be Detroit Edison Company, Pine Grove Substation Transit yard from at least 1948 until the present. Based on the age of the Substation Transit yard, PCBs potentially exist in the transformers. Therefore, SME recommends that the PCB content within the transformers be checked prior to demolition of the site, if deemed necessary. This site is identified as #13 on the attached **Figure 1**.

Site 14: The site formerly located at 2401 Pine Grove Avenue, located in the central portion of the Study Area appeared to be vacant land prior to 1953. From 1953 until the late 1980s, it was a gas station with various names throughout the years. From the late 1980s, until the present the site was vacant with a sidewalk and the beginning of the on-ramp to the Blue Water Bridge located on the site. The historical presence of a gas station located on this site represents a REC in connection with the Study Area. This site is identified as #14 on the attached **Figure 1**.

Site 15: The site located at 2425, 2445, 2447, and 2505 Pine Grove Avenue, located in the central portion of the Study Area appeared to be a machine shop from at least 1911 until the late 1940s. A railroad spur appeared to lead to the building from at least 1911 until the 1970s. There appeared to be exterior storage and soil mounds on the western portion of the site from the late 1950s until the late 1980s. There appeared to be three different businesses at this site from the late 1940s until the mid 1990s. From the late 1940s until the early 1980s, the site appeared to be also used for general contracting. From the early 1980s until the early 1990s part of the site also appeared to be a florist shop. From the early 1950s until the late 1970s, the northern portion of the site appeared to be used for sheet metal contracting. From the late 1970s until the early 1990s the northern portion of the site appeared to be used for commercial sales. From the early 1990s until the present the site is Can-Am Duty Free Store, and the southern portion of the site is the on-ramp to the Blue Water Bridge. The historical presence of: an auto parts manufacturing facility; sheet metal contracting; a railroad spur; exterior storage and soil mounds; and a current UST located on this site represent RECs in connection with the Study Area. These sites are identified as #15 on the attached **Figure 1**.

Site 16: The site located at 2539 Pine Grove Avenue, located on the northern portion of the Study Area appeared to be vacant agricultural land prior to 1950. From 1950 until the mid 1950s, the site appeared to be a fruit market. From the mid 1950s until the early 1960s the site appeared to be an auto dealership. From the early 1960s until the present the site appeared to be a gasoline station. The site is currently an Amoco Gas Station. The presence of a gas station located on this site represents a REC in connection with the Study Area. This site is identified as #16 on the attached **Figure 1**.

Site 17: The site located at 2624 14th Avenue, which is on the north-northwest portion of the Study Area, appeared to be a residential structure from 1948 until the mid 1960s. The site appeared vacant from the mid 1960s until the mid 1980s. From the mid 1980s to the present the site appeared to be Bufts Pennzoil Ten Minute Oil Change. Based on the presence of an oil change facility, SME considers this site a REC in connection with the Study Area. This site is identified as #17 on the attached **Figure 1**.

Site 18: The site located at 2037 Pine Grove Avenue, which is located on the southern portion of the Study Area appeared to be vacant prior to 1940. From 1940 until the early 1960s this site appeared to be a gas station. From the early 1960s until the present, the site appeared to be a one-hour, on-site, dry cleaner. The presence of an on-site dry cleaner and historical presence of a gas station represents a REC in connection with the Study Area. This site is identified as #18 on the attached **Figure 1**.

Bufs Car Wash, 2601 13th Avenue: This site reportedly had five USTs that were removed and taken to a Type II landfill. A majority of the site has reportedly been remediated and the impacted soil was disposed of at a Type II landfill. However, the site appeared to still have impacted soil on the eastern portion of the site extending beneath 13th Avenue and along the western wall beneath the utility areas and building foundation. Based on the information reviewed, this site represents a REC in connection with the Study Area. This site is identified as #1 on the attached **Figure 1**.

Speedway #8825, 2621 Pine Grove Avenue: This site is located on the northern portion of the Study Area. There are currently five USTs on the site, and there were historical USTs on the site also. Based on a Closure Report dated May 25, 2000 a release of petroleum products was identified on the site, and was presumed to be from an historical leak and not from the current USTs. The constituents consisted of BTEX, trimethylbenzenes, and PNAs. Groundwater was presumed to be approximately 4 feet below ground surface, and was indicated to be perched groundwater flowing in the south-southeast direction. Impacted groundwater was identified in five of the six monitoring wells located around the site. Therefore, this site is considered a REC in connection with the Study Area. This site is also discussed in Sections 3.2.2 and 3.5.5, and is identified as #2 on the attached **Figure 1**.

CaWood Auto Company, 2516 Pine Grove Avenue: This site appeared to have five USTs removed, and verification of soil remediation was conducted on October 25, 1990. According to the Closure Report by Eneco Tech, August 8, 1991, the excavation did not appear to have staining or discoloration. Approximately 120 cubic yards of soil was removed from the site. Groundwater from the excavation was removed by a vacuum truck. Based on the information reviewed, the impacted soil has been remediated. However, this site is currently an operating service station, which is further discussed in Sections 3.2.1, 3.2.3 and 3.5.5. The hydraulic lifts and potential hazardous chemicals at the site represent RECs in connection with the Study Area. This site is identified as #4 on the attached **Figure 1**.

Blue Water Bridge Maintenance Garage, 1410 Elmwood: This site reportedly had a release in 1991 and one in 1993. Based on the information reviewed, impacted soil was observed in 1991 due to releases from two 2,000-gallon USTs located on the northern portion of the site, which contained gasoline and diesel fuel. In 1993 a release was observed from a 1,000-gallon gasoline tank located in the central portion of the site. The release in 1991 reportedly was not completely remediated. The release identified in 1993 reportedly was remediated. Due to the presence of impacted soil along the southern portion of the site, SME considers this site a REC in connection with the Study Area. This site is also discussed in Section 3.6.3, and is identified as #7 on the attached **Figure 1**.

Bakers Dozen / Can Am 5027, 2308 Pine Grove Avenue: This site reportedly had five USTs removed, and approximately 13,000 cubic yards of soil excavated and disposed of at a Type II landfill. There appeared to still be impacted soil along the western portion of the site extending beyond Pine Grove Avenue. Based on the information reviewed, this site represents a REC in connection with the Study Area. This site was previously discussed in Section 3.5.5. This site is identified as #8 on the attached **Figure 1**.

London's Dairy, 2119 12th Street: This site reportedly had two USTs located on the on the western portion of the site. One of the USTs was a 500-gallon waste oil UST and the other was a 12,000-gallon gasoline UST. The contaminated soil was reportedly removed along with the USTs. There were reportedly impacted soils remaining on the east wall of the waste oil excavation. No contamination was identified based on analytical verification samples for the gasoline UST excavation. There is currently an active UST, which is further discussed in Section 3.2.2. Based on the indication of impacted soil along the east wall of the waste oil UST and an active UST in the central portion of the site, this site is considered a REC in connection with the Study Area. This site is identified as #12 on the attached **Figure 1**.

Amoco Oil Company, 2539 Pine Grove Avenue: This site appeared to formerly have gasoline, waste oil and fuel oil USTs. The soil was impacted by benzene, toluene, ethylbenzene, xylenes (BTEX), and polyaromatic hydrocarbons (PNAs). Groundwater was encountered approximately four to five feet below ground surface. According to a Closure Report, dated September 26, 1996, 315 cubic yards of impacted soil were removed from the site. According to the Closure Report, this site was remediated in regards to the former tanks on the site. However, this site is currently an operating gas station, which was previously discussed in section 3.2.2, and 3.5.5 of this report. This site is a REC in connection with the Study Area, and is identified as #16 on the attached **Figure 1**.

SME considered the three UST sites and a Closed LUST site: Speedway #7721 (Marathon Gas Station) located at 2610 Pine Grove Avenue; USA Mini Mart #315 located at 2432 Pine Grove Avenue; United 4006 Tulsa Oil Corporation located at 2401 Pine Grove Avenue; and World Duty Free located at 2425 Pine Grove Avenue RECs in connection with the Study Area because of the presence of USTs at the sites. Even though it appears that United 4006 Tulsa Oil Corporation has had the USTs at this site removed, based on the information from the MDEQ-WHMD website, indicating no release was reported, there was no record of verification sampling completed at this site. Therefore it represents a REC in connection with the Study Area. These sites are identified as #3, #5, #14, and #15 respectively on the attached **Figure 1**.

In the professional opinion of SME, a Phase II subsurface assessment for the sites numbered on the attached **Figure 1** to determine the amount of contaminated soils within the Study Area prior to construction of the Blue Water Bridge Plaza expansion.
